HEAT SOAKING OF TOUGHENED GLASS

Heat soaking is a test process that attempts to eliminate nickel sulphide inclusions, which can cause spontaneous fragmentation in toughened (tempered) glass.

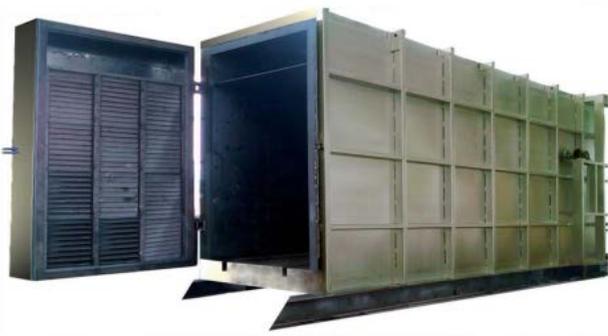
- The toughened glass is heated to 280°C (+ or - 10°C). Once all glass has reached that temperature, the cycle begins. (Sensors attached to the glass are used to monitor temperature.)
- After being held inside the heat soak oven for two hours, the glass is then allowed to cool to ambient temperature.
- The test is intended to encourage any NiS inclusions to expand to their original size.
- The test is **not** infallible, however, as transformation may continue after the heat soak process. As it only eliminates around 95% of potential failures, the test should **not** be considered a guarantee against the presence of NiS in float glass.
